The Royal Hotel Bangor

Steelwork Condition Report – Executive Summary

19053-DID-ZZ-XX-RP-0001

Royal Hotel, Bangor – Steelwork Condition Survey

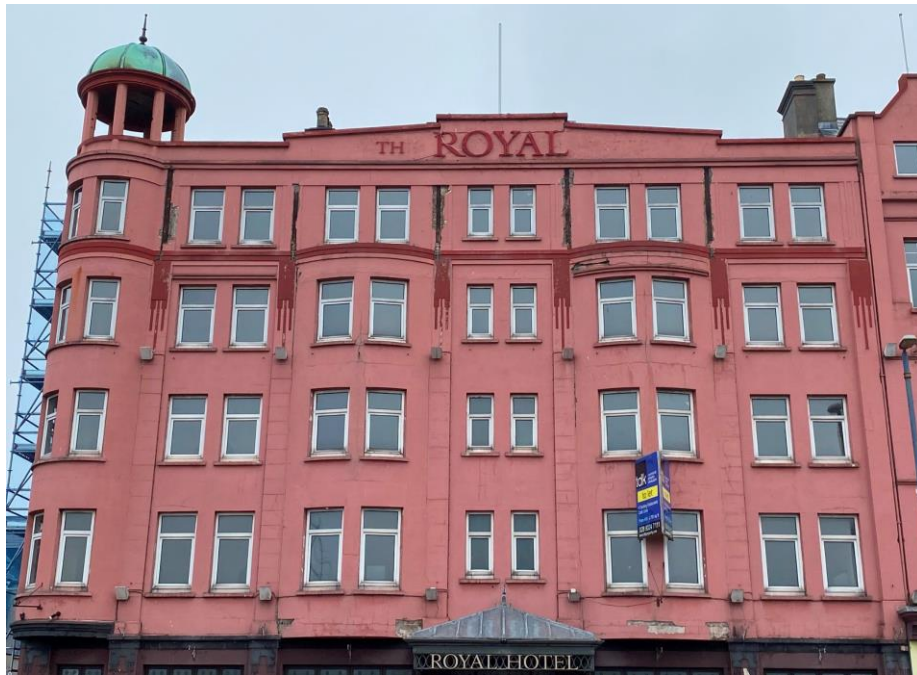
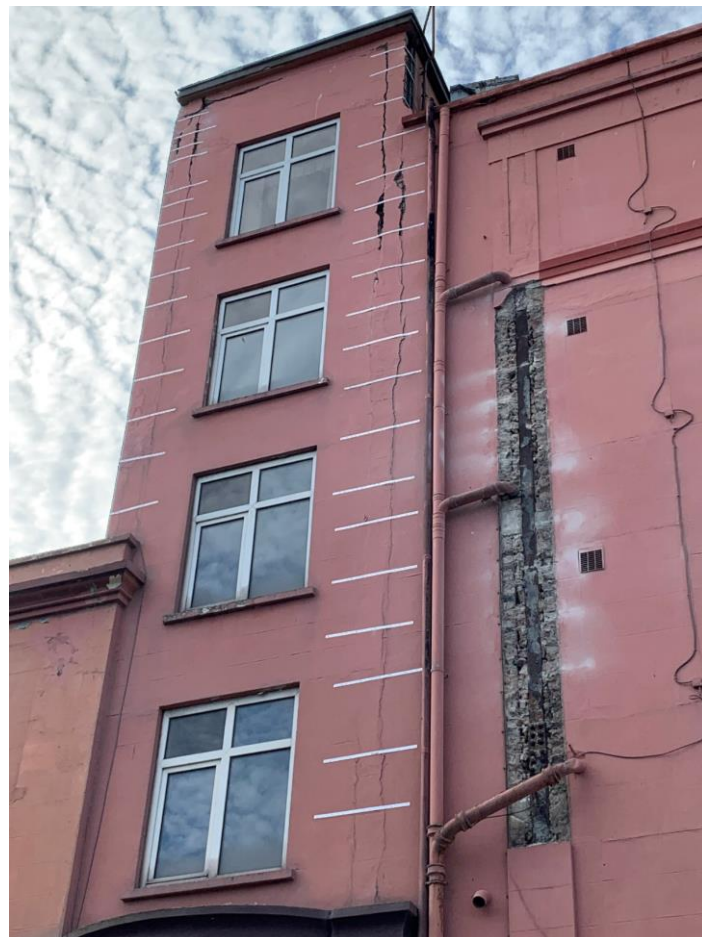
During the initial surveys carried out by Design ID in May and June a large number of defects were noted internally and externally. This was particularly pronounced on the external wall elevations. There were extensive areas of cracking and boast plaster that presented a health and safety risk to the general public due to the potential for these areas to spall and fall to the ground below. It was recommended to the client that loose areas of plaster should be removed to reduce the risk. Due to the severity of cracking and boast plaster to one particular area along Crosby Street it was recommended that strapping be provided as a temporary measure to maintain some restraint to the existing wall panels. Works were carried out by the clients appointed contractor in July 2020 to remove boast plaster and add strapping to wall panels along Crosby Street as illustrated in Figure 2. The measures undertaken at that time are short term measures and more permanent remediation was recommended to the client by Design ID. The cracking identified appeared to coincide with existing structural column and beam lines. Having identified that the existing structural form is a steelwork frame the initial assumption was that the cracking was formed due to corrosion and expansion of the steel.

Figure 2 – Images following removal of loose plaster and temporary strapping of existing walls taken in July 2020.

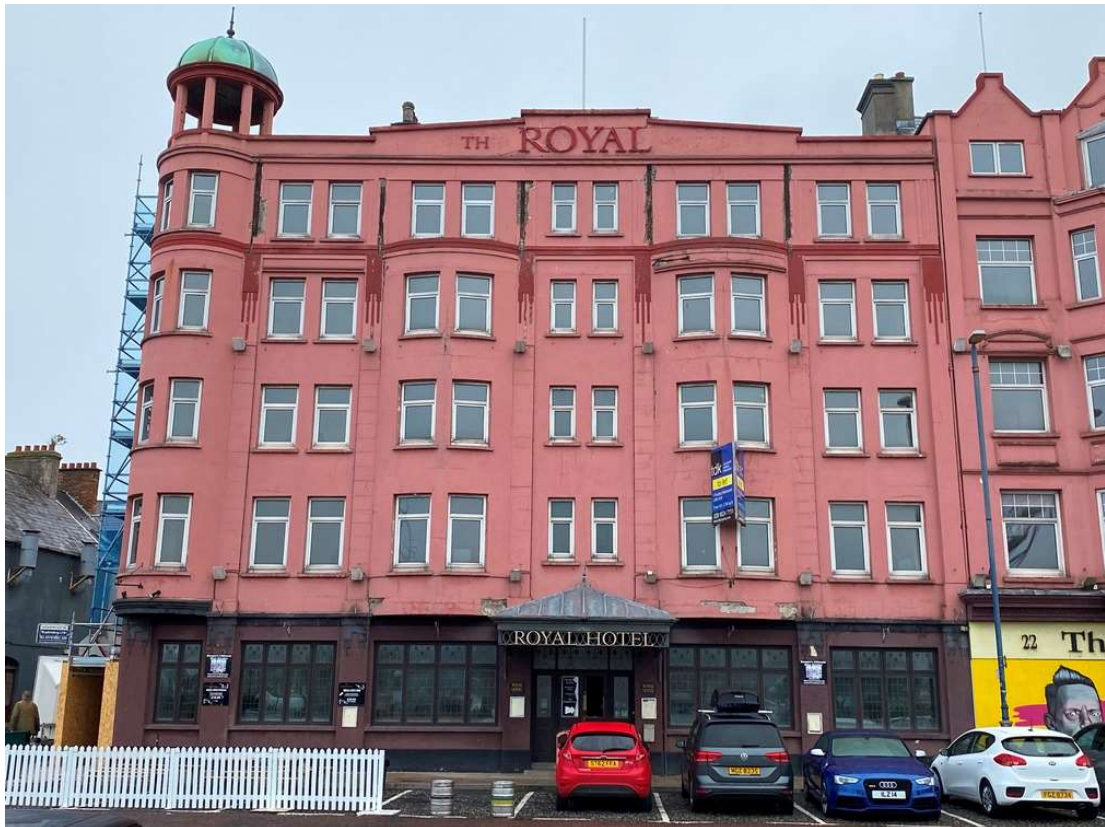
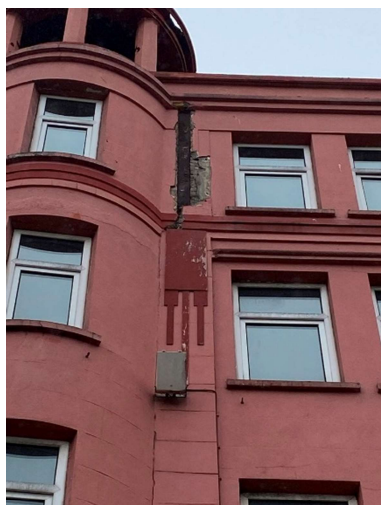
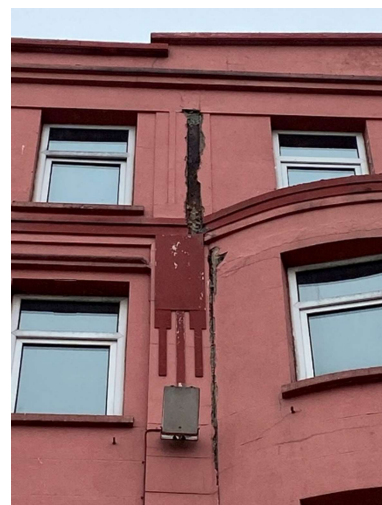
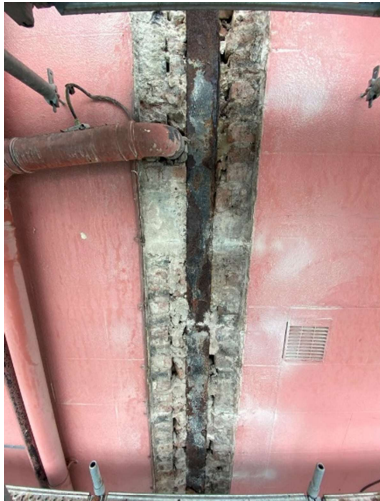
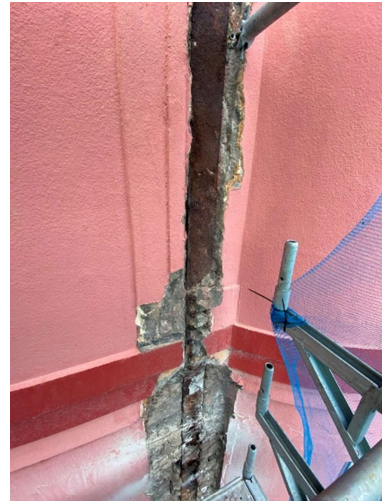
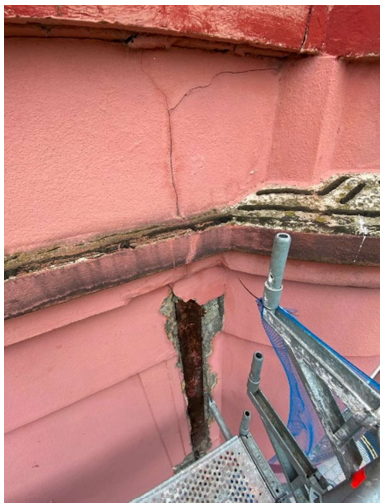
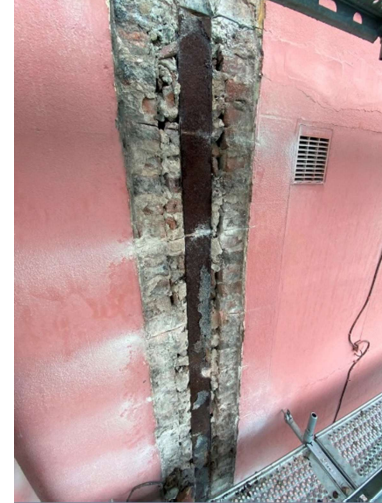
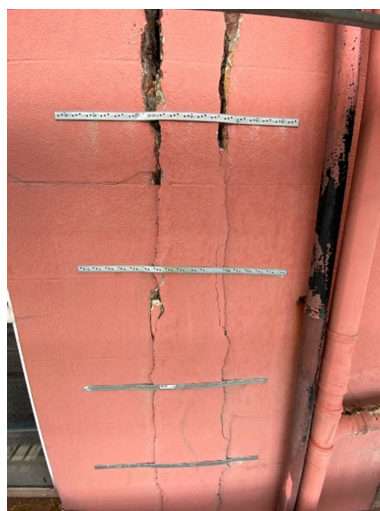
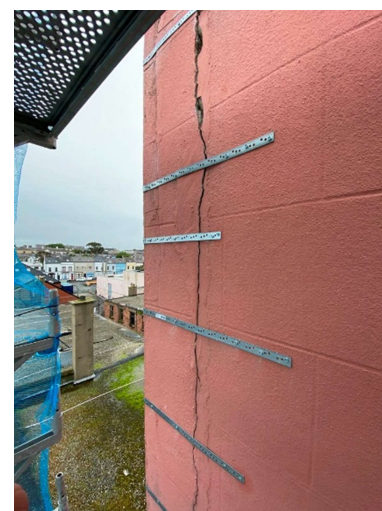
- Following removal of delaminated and loose rendered elements by a contractor in the weeks preceding our inspection, numerous instances of the exposed steel columns were observed. On the front elevation of the structure, the majority of deterioration was observed on the top floor (Plates 1 to 3). On the Crosby Street side elevation, render was removed exposing the columns over the top 3no. floors (Plates 4 to 7). The contractor had installed a number of straps on this elevation to prevent further loose material from falling (Plates 8 to 9).

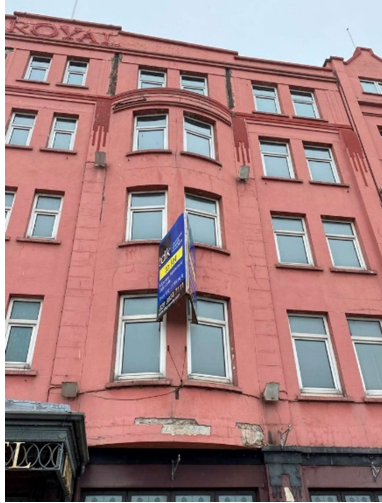
**Plate 10**

- Numerous cracks remain on the external elevations directly over steelwork locations (Plate 10) with bulging of the façade evident in localised areas (Plate 11).

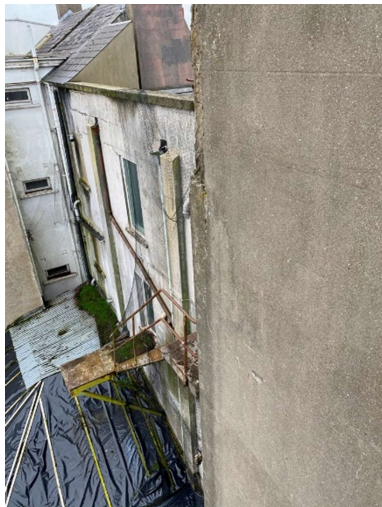
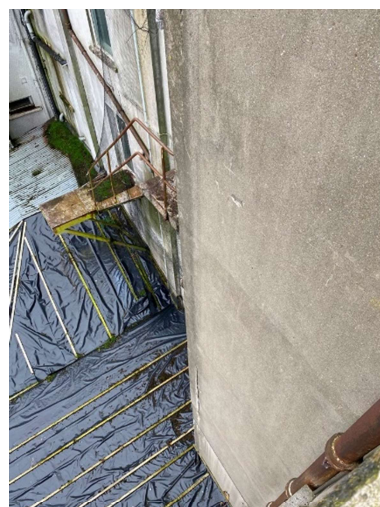
- From the limited viewing angles of the rear elevation, spalled material over the column to the rear of the lift shaft was observed as well as cracking on the main elevation (Plates 12 to 13).

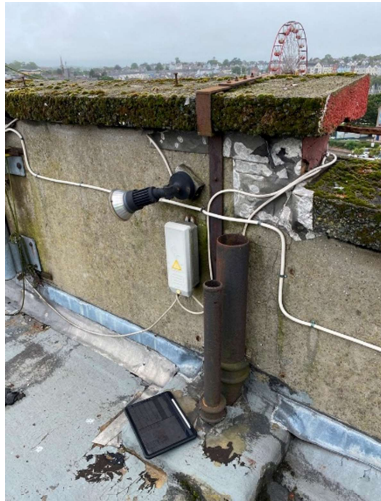
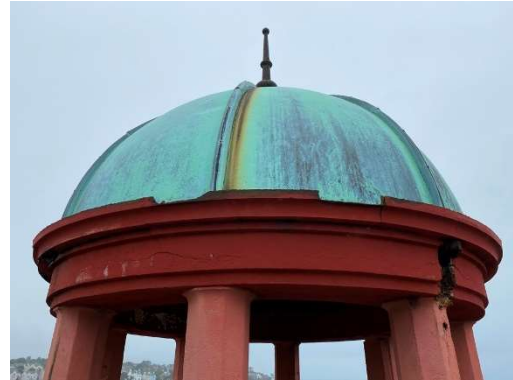
- At roof level, evidence of prior attempts to waterproof the structure using patches of membrane was observed in localised areas (Plate 14). Cracking and corrosion staining were also observed on the various elements of the ornate dome structure at the corner of the building (Plate 15).

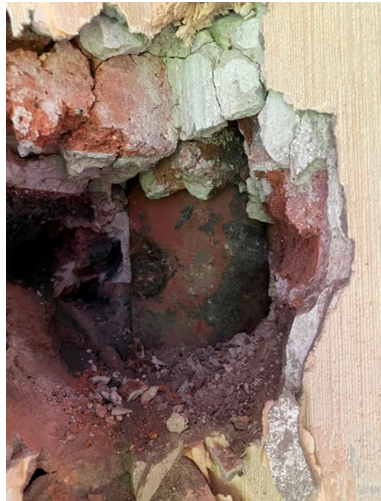
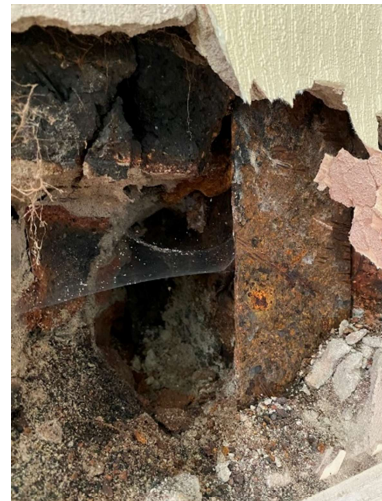
- Internally, numerous localised breakouts around the steel frame had been undertaken by others. For the most part, where the frame has been exposed internally on the external elevations, corrosion to varying degrees of severity was observed (Plates 16 to 17).

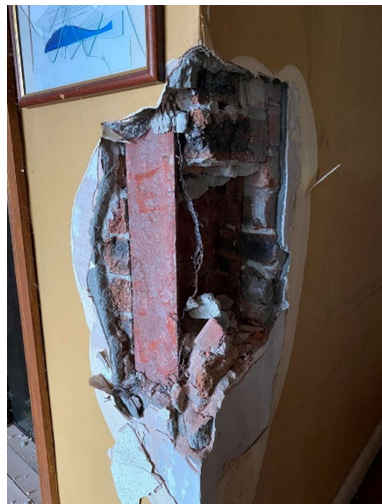
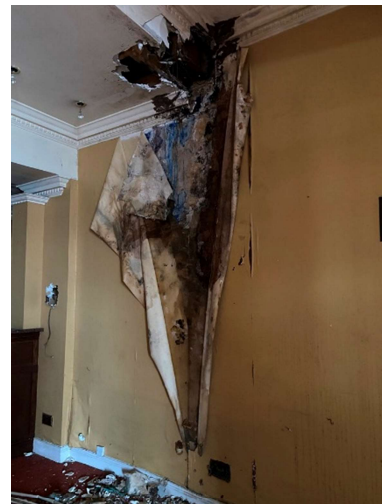
- The internal steel frame was observed to be in good condition at the majority of locations where breakouts had occurred (Plate 18). Corrosion was observed at locations where saturation and staining was evident (Plate 19). Saturation of walls and ceilings was observed on the majority of floors in localised locations, the extents of which are annotated on the floor plans provided in Appendix B. Localised cracks and delamination on internal walls and ceilings was also observed in localised areas, the majority of which is considered to have been caused by normal building movements.

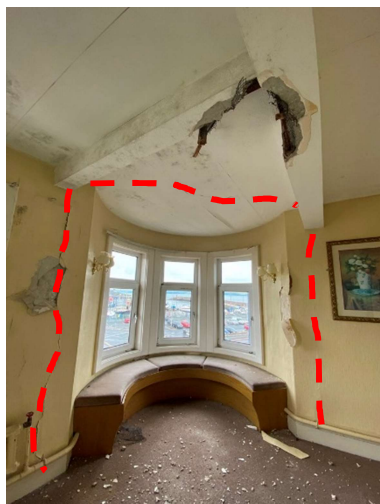
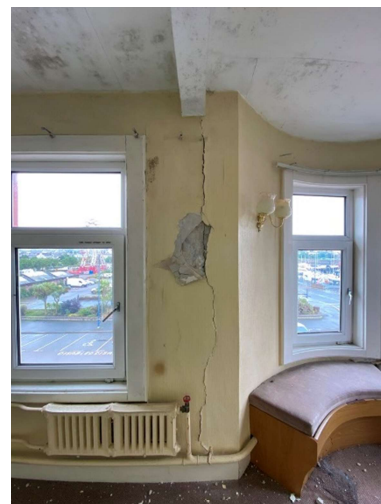
- Consistent cracking across all floors was observed on the north west corner of the building, directly below the ornate dome structure (Plates 20 to 21). Although evidence of corrosion was observed in these areas, particularly on the external columns, we are unsure if this cracking is also structural and should be assessed further by others.

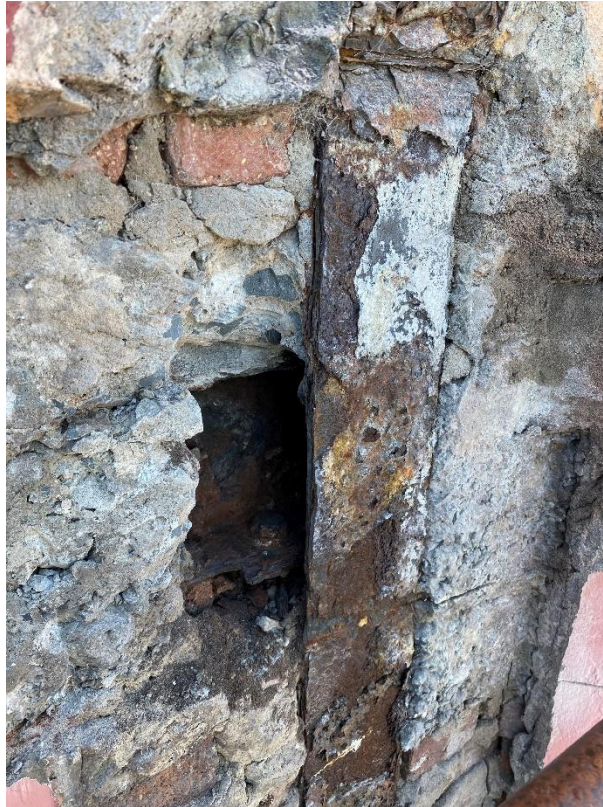
Photo 1 – Crosby Street 4th Floor beam to column connection – Severe corrosion and de-lamination of column flange evident.

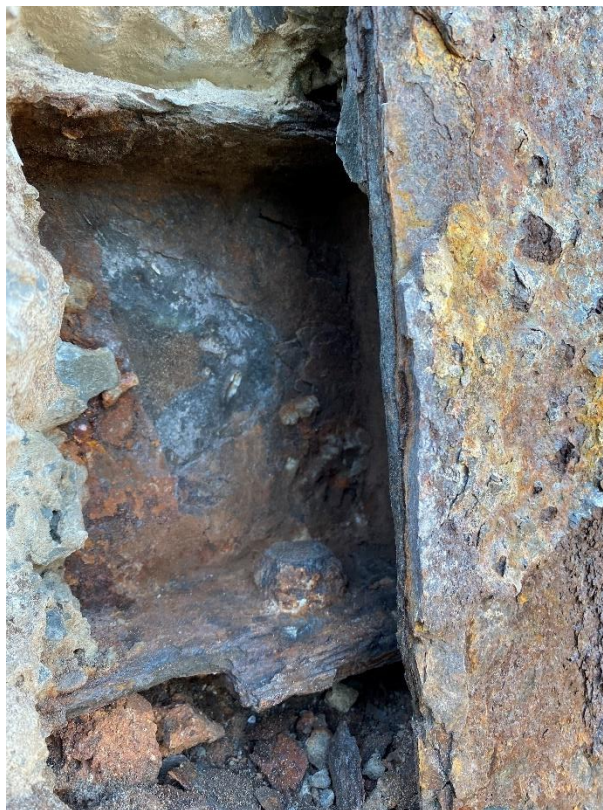
Photo 2 – Crosby Street Column flange with severe section loss and de-lamination of incoming steel beam.

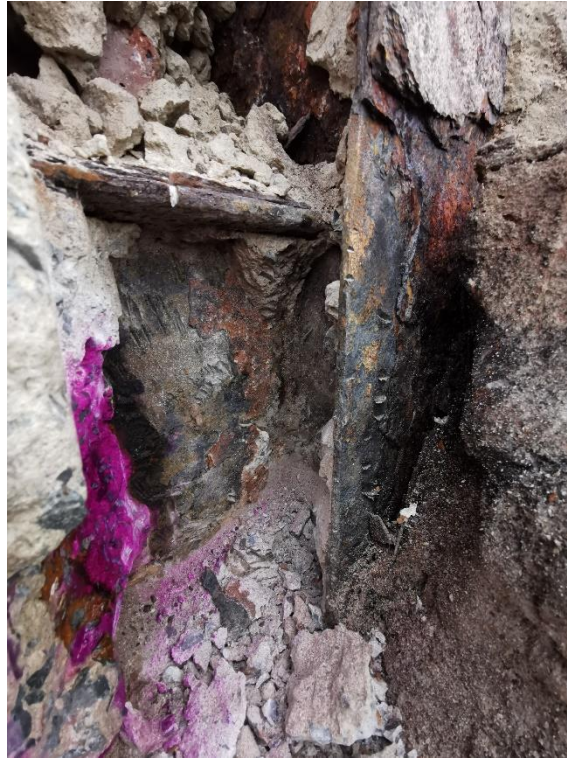
Photo 3 – Quay Street Column Beam to Column Connection at 1st Floor level. Severe section loss and de-lamination of column flange evident.

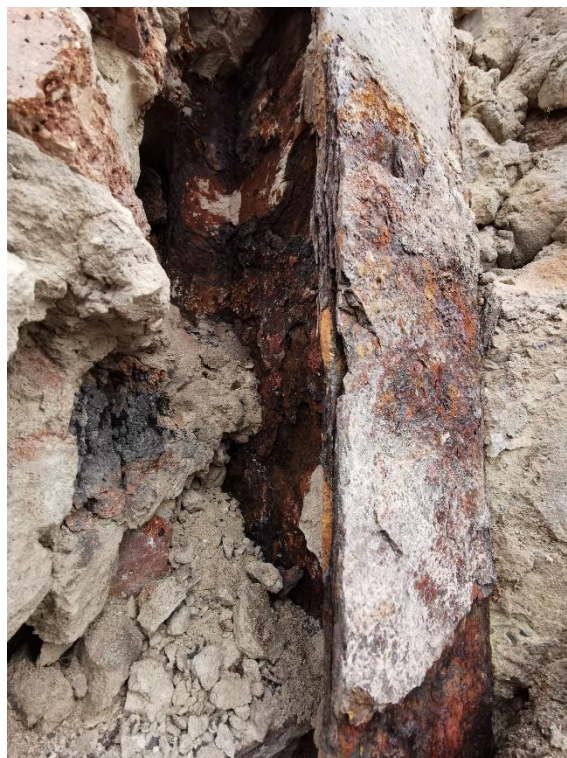
Photo 4 – Photo of column flange on Crosby Street Elevation. Significant de-lamination of column flange.

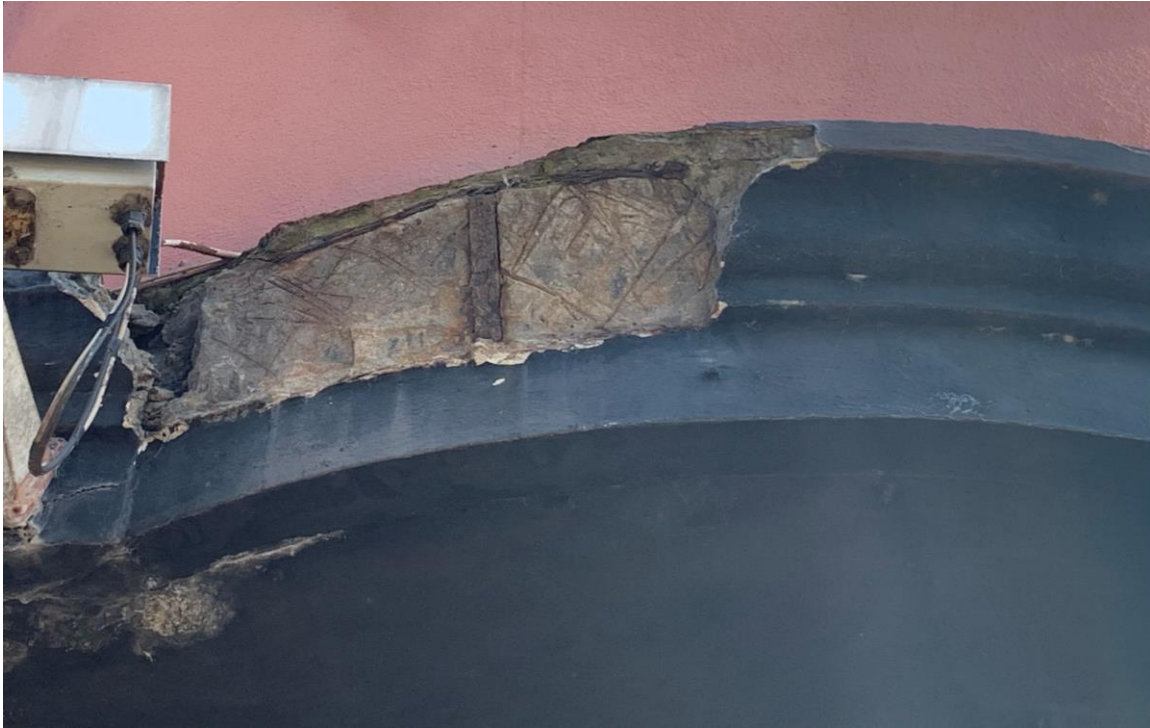
Photo 5 – First floor curved steel beam at corner of Crosby Street and Quay Street. Corrosion and de-lamination of steel top flange is present.

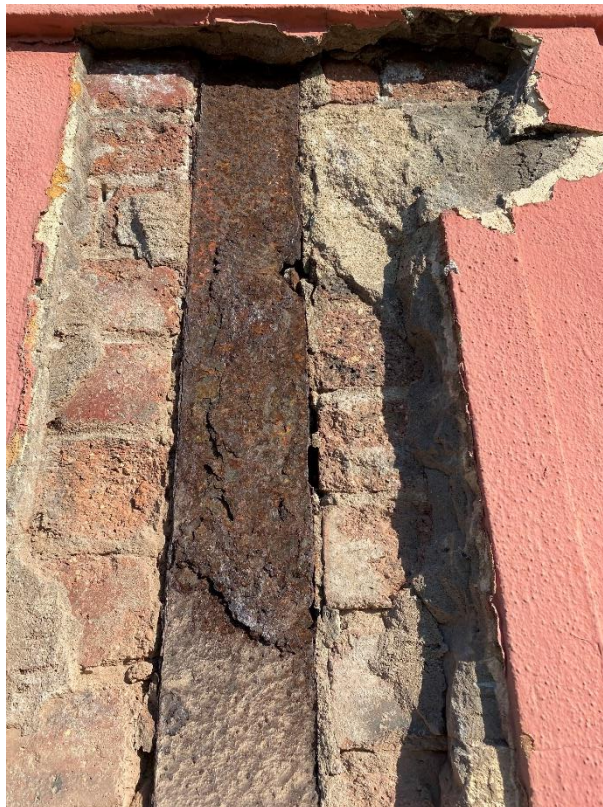
Photo 6 – Quay Street Column showing the typical relationship with the external solid brick wall. The photo indicates de-lamination of the steel flange.

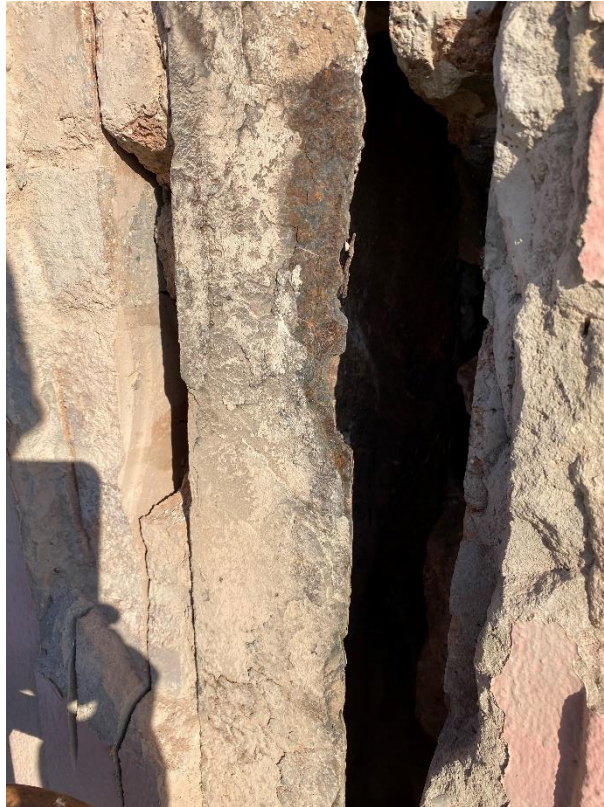
Photo 7 – Quay Street Column at 4th floor level. Severe section loss of columns evident.

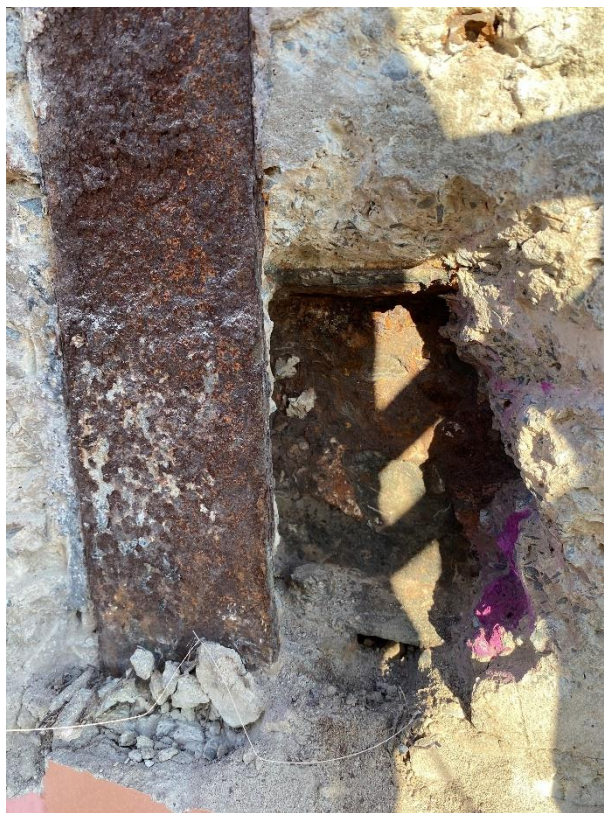
Photo 8 – Crosby Street Beam to Column Connection. Column and incoming beam indicate signs of corrosion and de-lamination.
