ARCHAEOLOGICAL PROGRAMME OF WORKS

Report	Archaeological programme of works
Project	Former Royal Hotel and Windsor Bar, Bangor
Planning Ref.	LA06/2017/1209/F
Grid Ref	Centred on 350,590 382,086
Date	22/05/2020

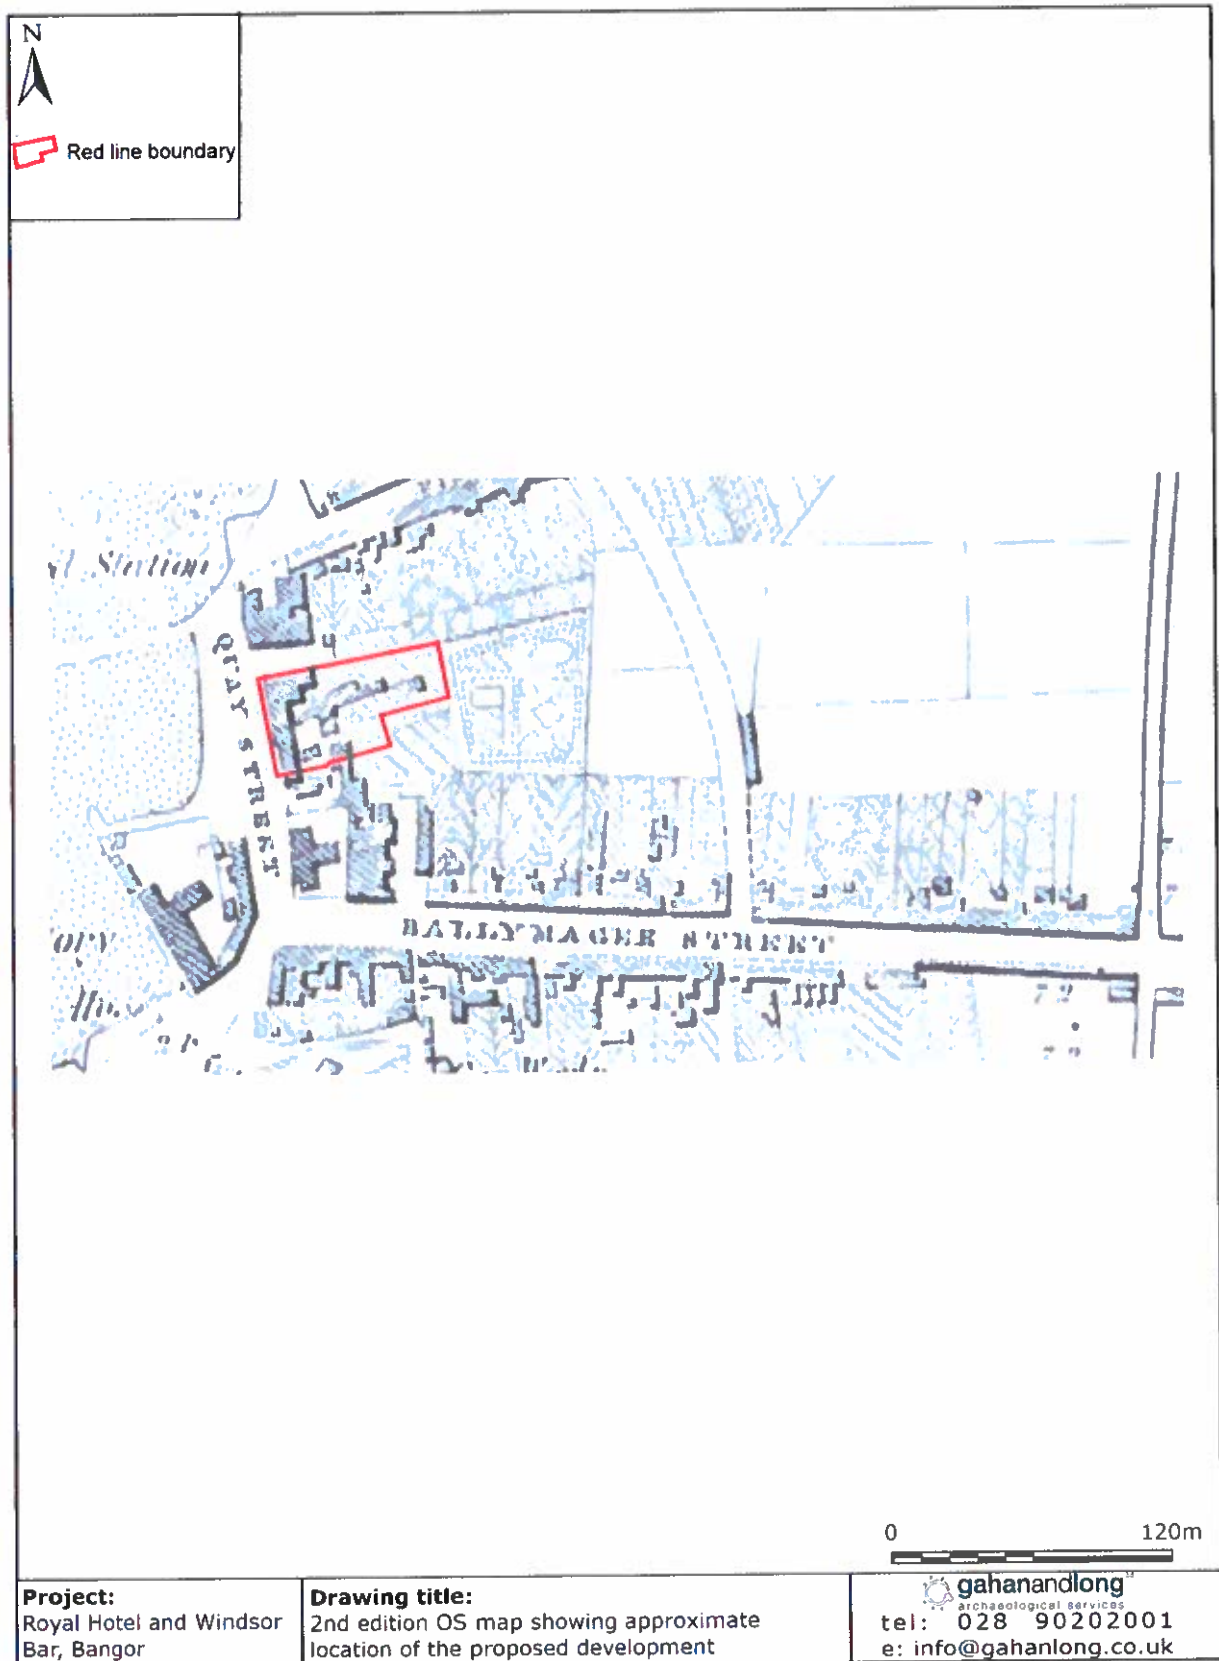
Figure 4: 2nd edition OS map showing approximate location of proposed development site.

A review of the early editions of the Ordnance Survey maps was also undertaken. While the 1st edition map was unavailable the 2nd and 3rd editions were inspected (figures 5 and 6). The 2nd edition map which dates to 1860, Quay Street is clearly labelled and a number of buildings are shown, as are formal gardens to the rear of the properties (figure 5).

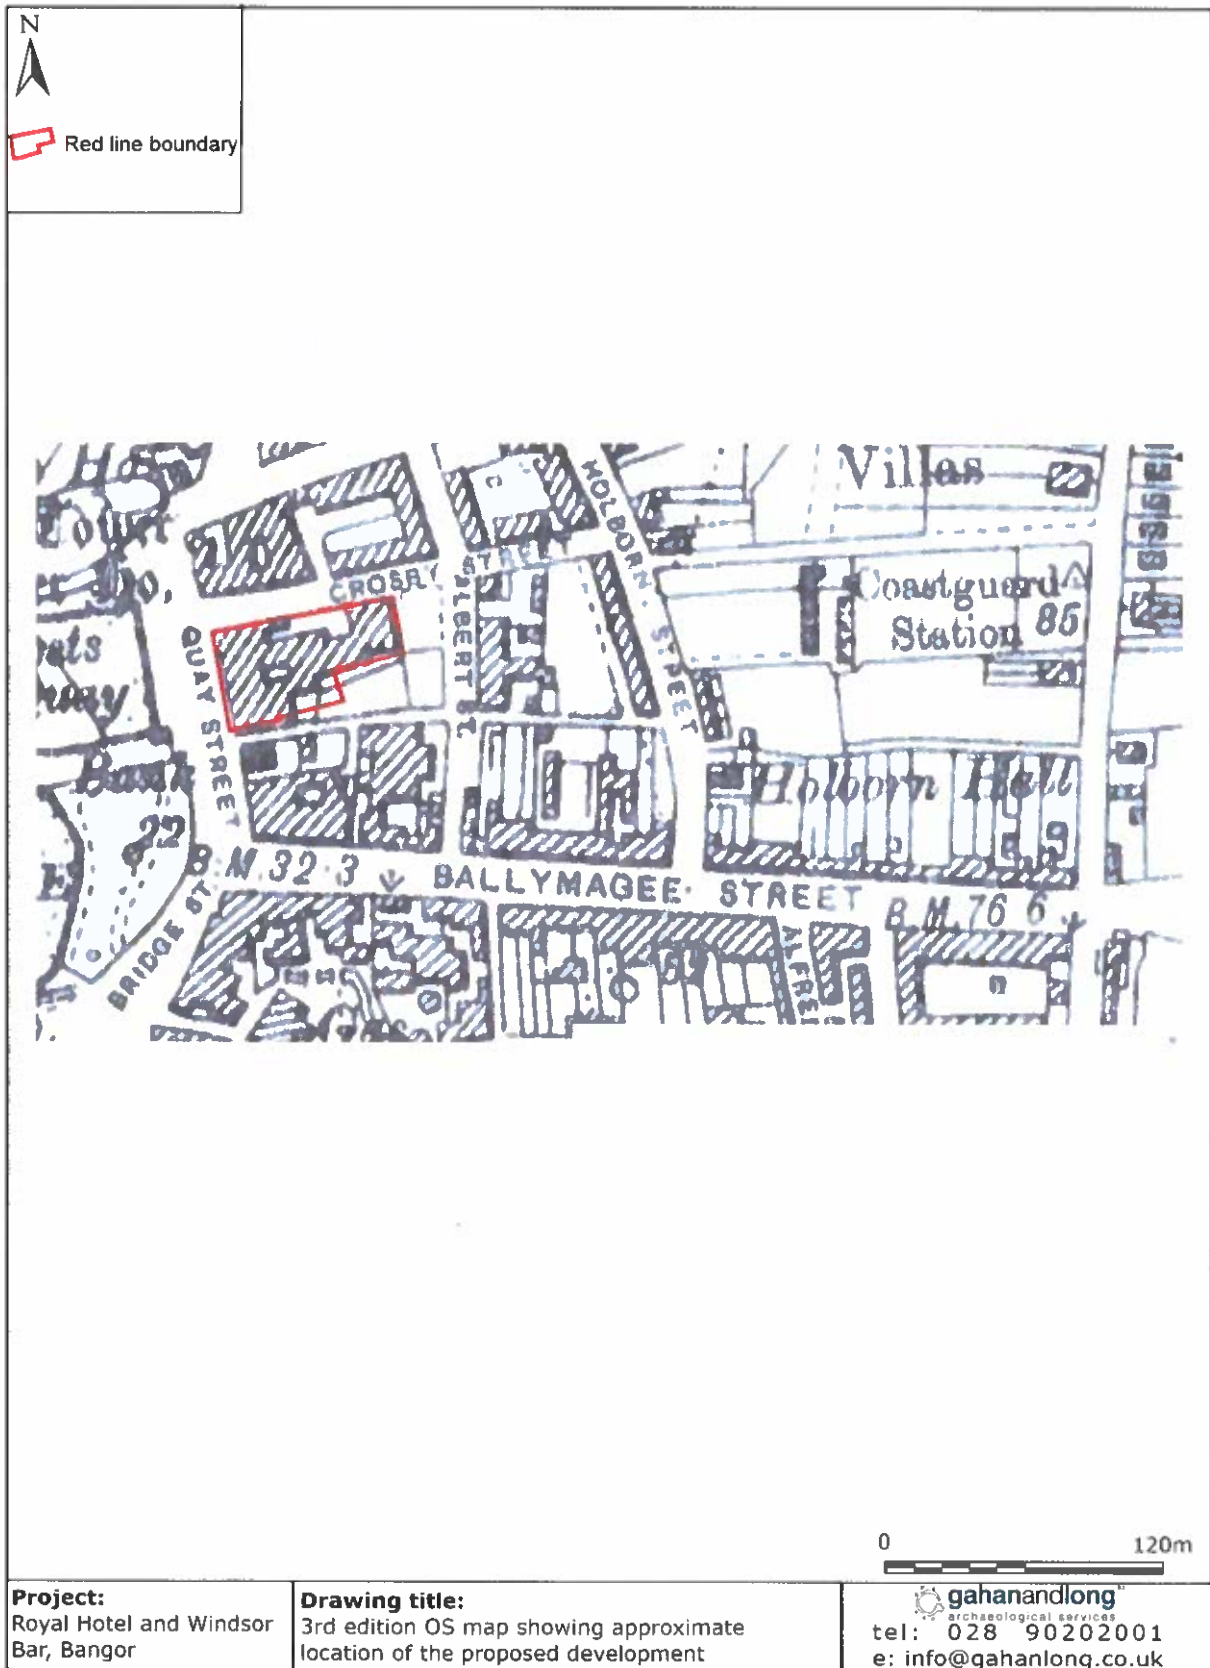
Figure 5: 3rd edition OS map showing approximate location of proposed development site.
