ARDS & NORTH DOWN BOROUGH COUNCIL

ECOLOGICAL BASELINE SURVEY  
FOR ENVIRONMENTAL IMPROVEMENT SCHEME  
AT WARD PARK, BANGOR

SEPTEMBER 2016

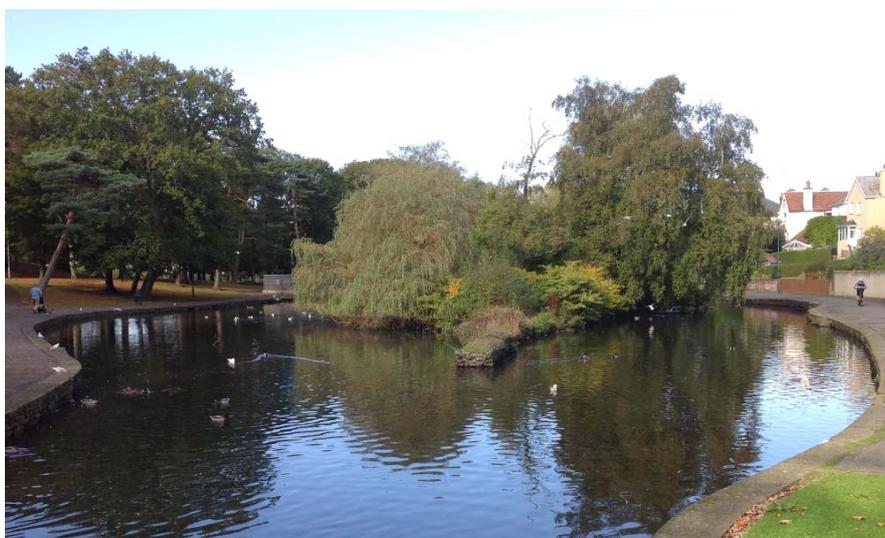
Photo 1: Wooded islands on the middle pond at Ward Park, viewed from the south.

- 2.3 The ponds and interconnecting channels have vertical edges, formed of concrete and stone, and the pond islands have been constructed using gabions and these too form vertical edges.
- 2.4 The aquatic ecosystem is almost totally lacking in aquatic vegetation; submerged macrophytes and emergent aquatics are scarce.
- 2.5 The ponds and interconnecting channels are bordered on either side by a broad belt of mostly mature parkland trees. Ground cover under these comprises improved grassland (Photo 2) and this is maintained by close mowing and, in places, grazing by flocks of feral geese and ducks. In some places a more natural ground flora exists and this comprises native grasses and plants.

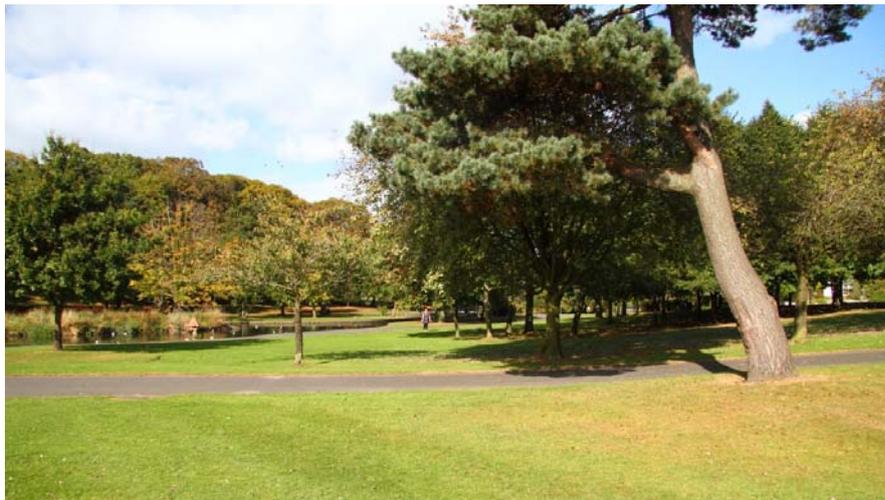
Photo 2: Mown grass and parkland trees to east of Upper Pond, habitats which are typical of Ward Park.

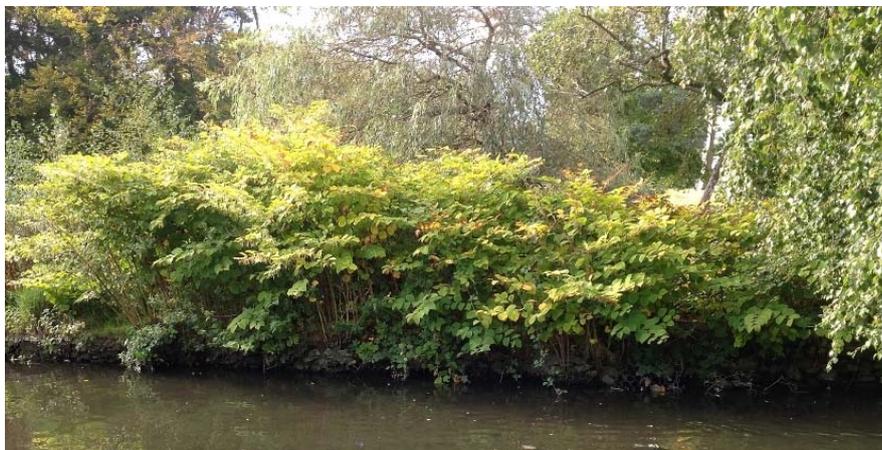
- 5.1 It was clear from the first viewing of Ward Park that the invasive alien Japanese Knotweed *Fallopia japonica* was present, at least on the middle pond islands (Photo 3). This species was probably accidentally introduced when work was being carried out on the pond islands in the 1970s and gravel spread on the islands.

Photo 3: Stand of Japanese Knotweed on middle pond island

- 5.2 Japanese Knotweed is a large herbaceous perennial plant that is native to eastern Asia. It was introduced to the UK as an ornamental plant in the 19<sup>th</sup> Century and has spread widely, particularly along watercourses. It is rhizomatous (produces underground stems) with distinctive branched hollow, bamboo-like canes and can grow to over 3m in height. Although seeds are produced they rarely survive and the principal means of spread is through deliberate or accidental movement of rhizome fragments or cut stems.

5.4 Shaun Wolfe-Murphy (SWM), in his report (section 3.0 above and Appendix B) comments that eradication of Japanese Knotweed from the island is highly recommended if any landscaping works are to be carried out. He suggests that this ought to be done by the application of herbicide through stem injection only, due to the proximity of the stands to water. Consent for use of herbicide near a watercourse is required from NIEA Water Management Unit, Lisburn. SWM recommends that the best approach would be to trim areas where the plant has been mapped in winter, i.e. outside the bird breeding season and after the vegetation has died down. This will remove brambles and facilitate easier access for herbicide treatment the following summer.

- 5.7 It is recommended that an Invasive Species Management Plan is prepared during the detailed design stage of the Environmental Improvement Scheme. This would detail the methodology to be employed to eradicate the Japanese Knotweed on the middle pond islands prior to any works being undertaken in this area.

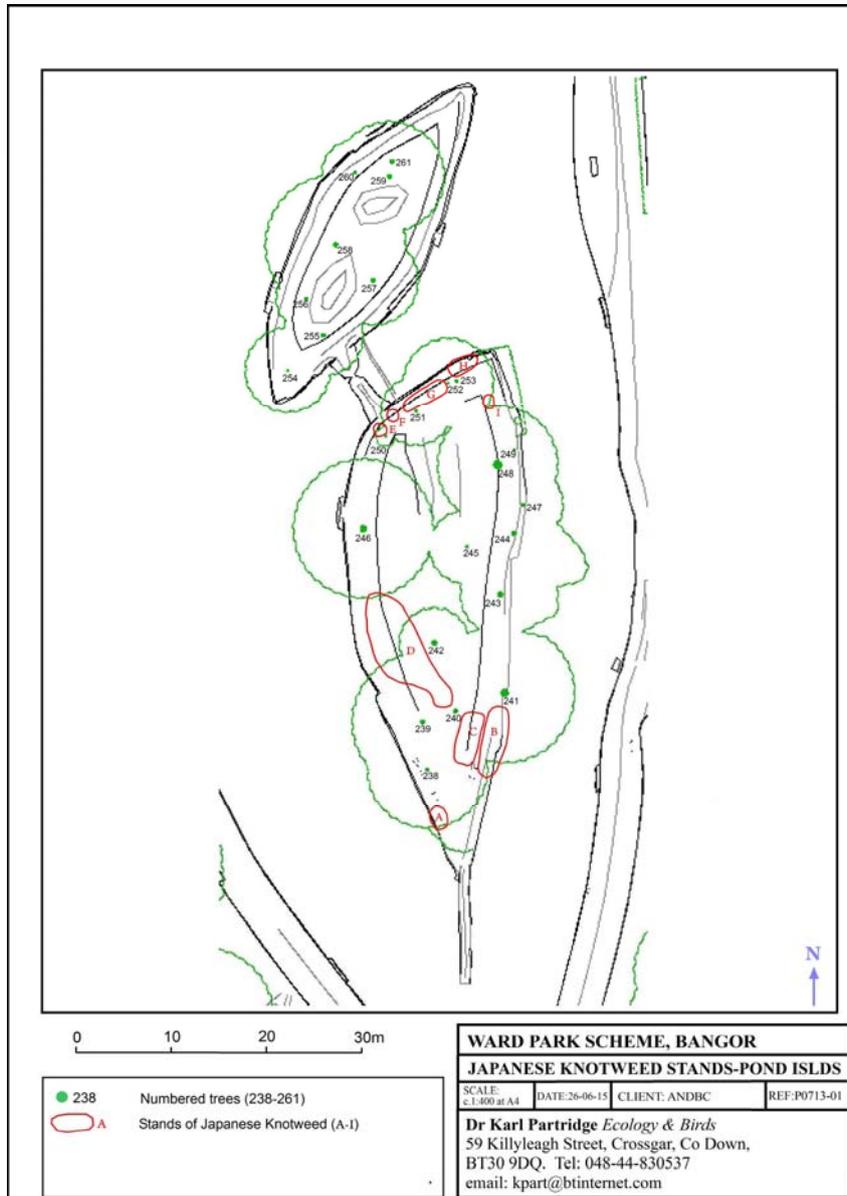
- 5.3 The distribution of Japanese Knotweed on the middle pond islands was mapped in June 2015. Also, the maximum height and stem diameter of each stand was measured. Figure 1 and Table 1 show that there are nine stands of Japanese Knotweed, all on the larger of the islands. These stands vary in extent from 15m long (stand D) to 2m (stand E). The canes vary in height from 1.5m to 3.0m and the stems measure between 27mm and 33mm in diameter.

Figure 1: Distribution of Japanese Knotweed on Ward Park middle pond islands, June 2015.

Table 1: Details of Japanese Knotweed stands on Ward Park middle pond islands.

5.5 The work should be done by a qualified landscape contractor and all material disposed of according to legal requirements and using best practice.
