Re: Royal hotel, 22-28 Quay Street, Bangor, Co. Down

Further to your instruction we have reviewed the current planning application documents and have undertaken visual inspection of the exterior of the building (on 26/07/2022) and of the interior (on 11/08/2022). The purpose of this review and inspections is to assess the feasibility of retaining the existing façade of the Royal Hotel Building.

Cathodic Protection of Early Steel Framed Buildings

Technical Note 7

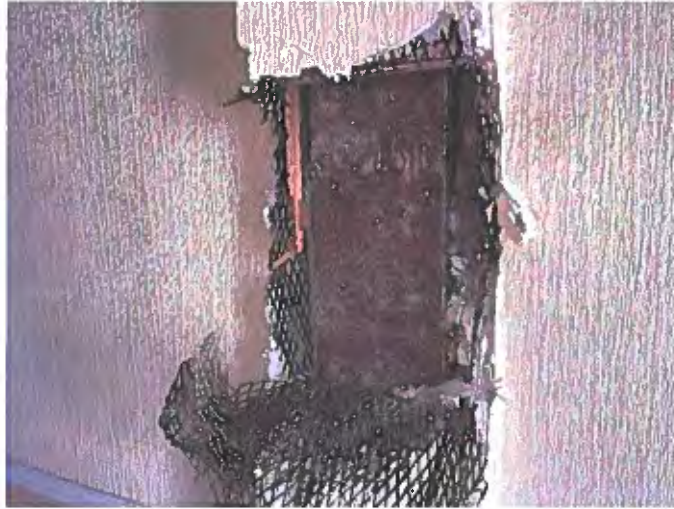
Our visual inspections confirmed that the structure of the building comprises a five-storey steelwork frame of columns and beams supporting poured in-situ concrete floor-slabs. Our observations confirmed that corrosion of the steelwork varies from minor (at the drier interior locations) through moderate (at areas affected by water ingress/leaks etc) to severe (on steelwork embedded in the façade).

Figure 2.0 Interior Dry Area Corrosion

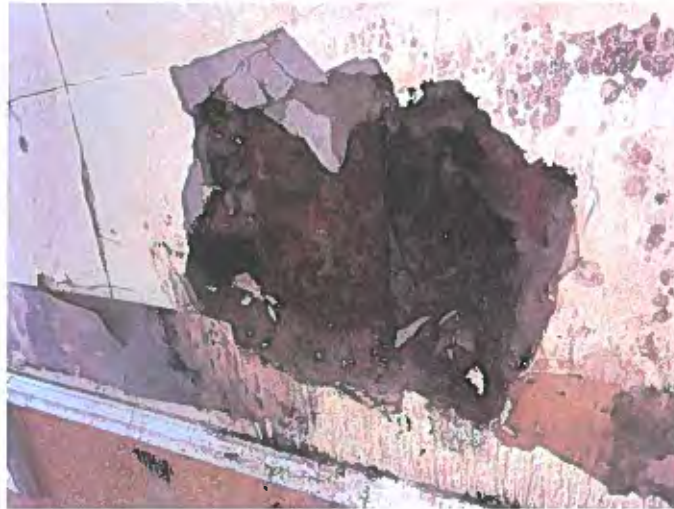
Figure 3.0 Interior Wet Area Corrosion

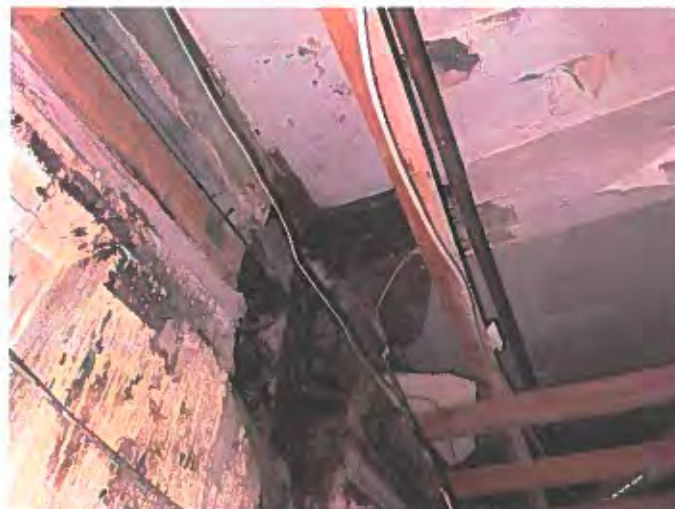
Figure 4.0 Façade Steelwork Corrosion

These observations are consistent with the findings of the Design ID report and we agree that the absence of effectual protection on the façade steelwork and the adverse changes (to the plaster coating and mortar covering the steel) caused by the aggressive marine environment of the building's location have led to the severe corrosion.

With respect to options to address the severe corrosion of the façade columns we recommend that consideration should be given to a Cathodic Protection (CP) approach. There are precedents (e.g., Shelbourne Hotel, Dublin and Parker Street, Liverpool) for successful use of Cathodic Protection of embedded steelwork in historic facades, involving the use of embedded, discrete hybrid-anodes with initial application of an impressed current, from an external electrical source, to render the steel passive followed by anode self-generated galvanic-current to maintain passivity in the long term.

The approach could be detailed with enclosures to allow access to the installed system from inside the building. Since the external cover to the façade columns is a relatively thin render the system would need to incorporate a high-specification coating to the outer face of the façade columns allowing the embedded anodes to provide protection to the other, embedded, faces of the columns.

Should the present loss of column cross section, to corrosion, have significantly compromised the loadbearing capacity of the columns it would be possible to supplement capacity by introducing additional columns (e.g., RHS steel sections minimising interior projection) placed against the internal face of the façade below each floor beam location.

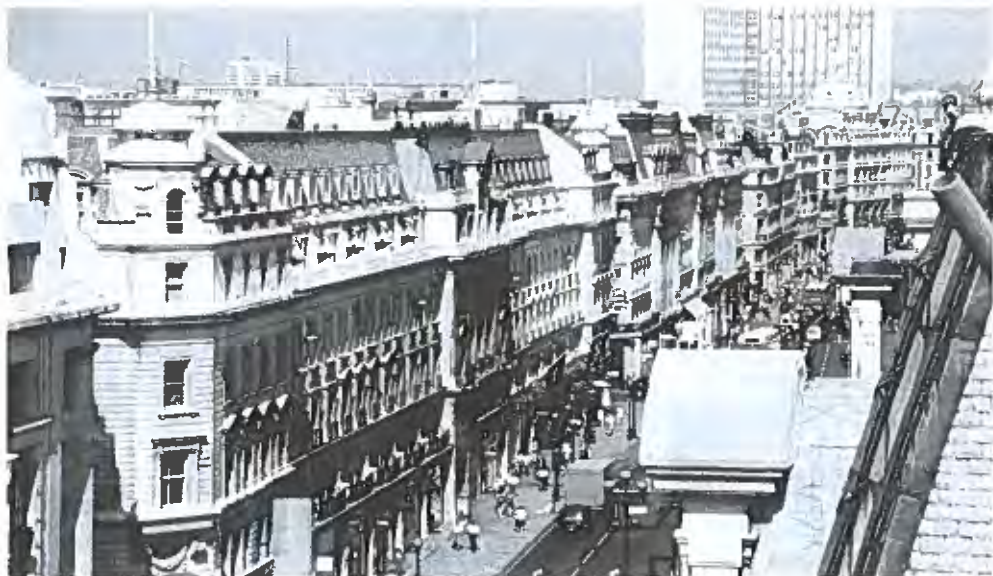
Steel framed buildings are located in most major towns and cities of the UK. The most widely recognised steel framed buildings of the UK are probably those found in Regent Street, London (see front page) where the problems of corrosion have been so common that steel frame corrosion is commonly referred to as 'Regent Street Disease'.

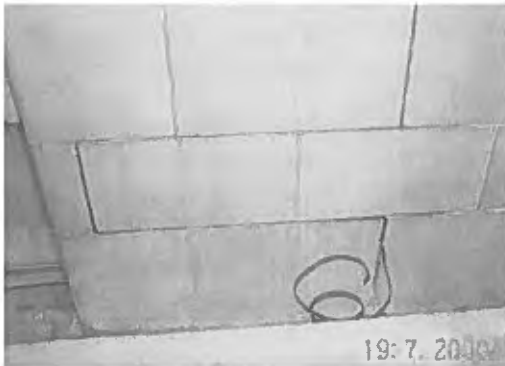
With regard to steel framed buildings, there are two main choices of anode: mixed metal oxide coated expanded titanium mesh ribbon anodes (see pic 2) and discrete rod anodes (see pic 3). Expanded mixed metal oxide coated mesh anodes have several distinct advantages in that:

- the anodes are not visible in mortar joints
- the anodes can be installed using standard masonry pointing techniques at the time of external repairs
- the anodes can often be situated parallel to beams and columns
- they cause minimal internal disturbance.

Photograph 2: Ribbon anodes in ashlar jointing

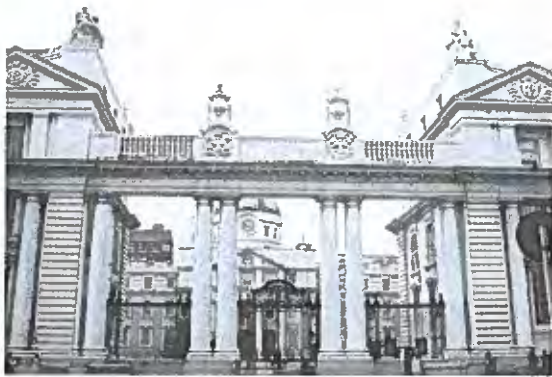
Photograph 4: Royal College of Science, Dublin, Eire

The first CP system for the prevention of steel corrosion in a masonry structure was installed in 1991. This system protects the entrance colonnade at the Royal College of Science, Dublin; a limestone structure containing two parallel structural 'I' beam members. Regular remote monitoring and annual visual inspections have confirmed that corrosion has been arrested.

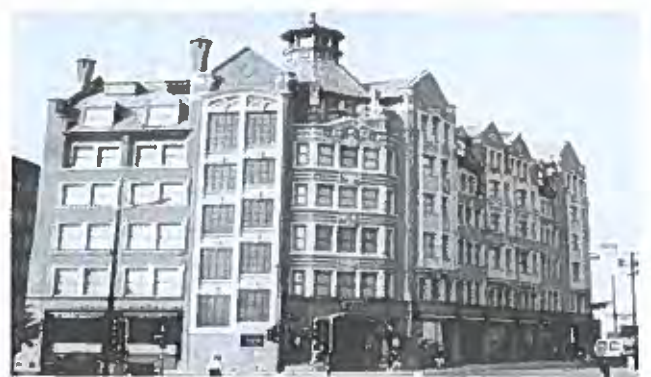
The full-scale application of cathodic protection to complete building facades took place in 1996. Typical examples of these early systems include the faience facade of Gloucester Road Underground Station, which is protected by a discrete rod anode system, and the Joshua Hoyle Building, Manchester; a brickwork and terracotta facade protected using expanded MMO coated titanium mesh ribbon anodes inserted in the mortar jointing.

These systems have shown the possibility of protecting full building facades and the versatility of CP systems for listed buildings. In the case of Joshua Hoyle, the use of CP to protect two five storey facades was found to have a cost saving in excess of 50% in comparison with traditional approaches involving the removal of masonry, painting of the steel followed by the reinstatement of the masonry.

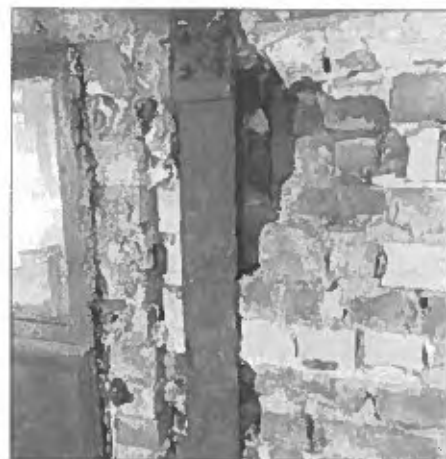
The rear brickwork face of the building was exhibiting cracks and some bulging. Exposure of the steel frame indicated corrosion in numerous sections had occurred, leading to formation of expansive corrosion products which in turn was applying disruptive pressure to the brickwork.

Corrosion found on the rear brickwork face of the building

In order to stop ongoing corrosion and prevent further damage at the Parker Street Building CPT designed a DuoGuard™ hybrid anode system. Initially the bulging brickwork was removed to expose some of the steel I beams. DuoGuard anodes were then installed into the mortar surrounding the beams to deliver a protective current to the steel. Using an external power source, an impressed current was applied to stop active corrosion and render the steel passive. The DuoGuard anodes were then disconnected from the power source to self-generate a galvanic current, sufficient to maintain steel passivity and control corrosion.

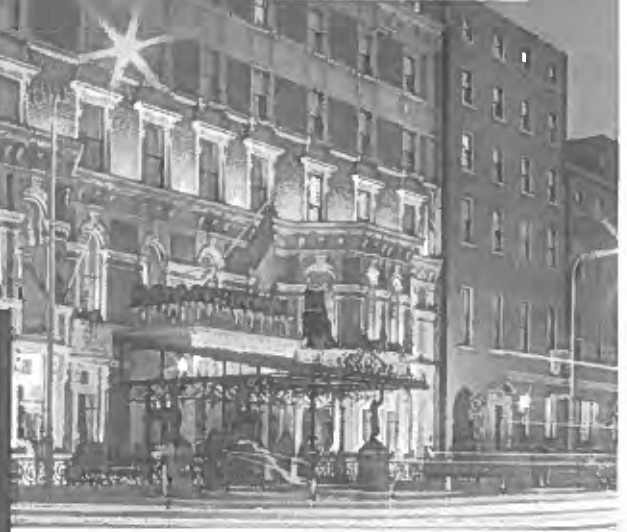
The Problem Identified

During external work to the Shelbourne Hotel façade it was noticed that the structural steel work was corroding and causing cracking to the encasement material. The material surrounding the structural steel was identified as a clinker concrete by its dark colour and extensive voids.

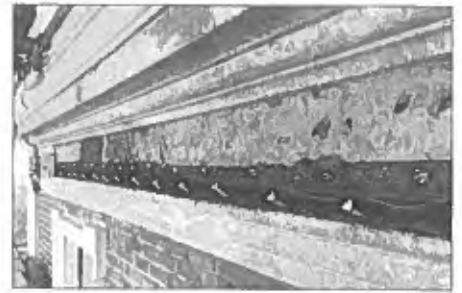
Testing found that all corrosion rates were above the threshold for passive steel. In addition, the fully carbonated concrete was providing no protection against corrosion. A DuoGuard™ hybrid anode system was designed to halt the ongoing corrosion and prevent future damage. Using an external power source, an impressed current was applied to stop active corrosion and render the steel passive. The DuoGuard anodes were then disconnected from the power source to self-generate a galvanic current, sufficient to maintain steel passivity and control corrosion.

A trial was done before the full system installation to ensure compatibility with the clinker/steelwork arrangement and to collect on site data to aid design. During the impressed current phase, the clinker concrete let current freely pass between the anode and steel. In phase two the galvanic current output was effective at maintaining steel passivity at a spacing of 300mm between installed anodes.

Shelbourne install

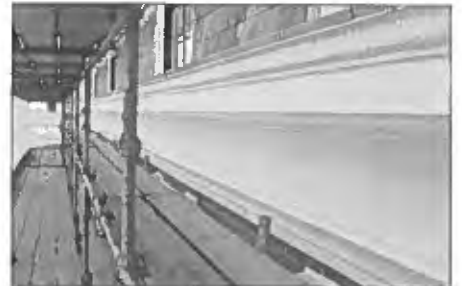
Corrosion related deterioration of the Shelbourne Hotel was halted. After the initial power up period, the self-powered DuoGuard hybrid anodes minimise all future maintenance requirements and associated life costs.

Shelbourne complete
